**PROJECT:** Midnite Mine Remediation**REPORT NO:** 2021-06**OWNER:** Newmont/Dawn Mining**OPERATOR:** Newmont/Dawn Mining**SUMMARY OF WORK ACTIVITIES OR EVENTS FOR THIS REPORTING PERIOD:**

This weekly report provides a summary of Midnite Mine Site (Site) remediation action (RA) construction activities, quality assurance (CQA), quality control (CQC) and engineering activities for the period April 30 – May 6, 2021. The Site activities discussed in this weekly report include, but are not limited to: Site Health, Safety, and Security; Community Liaison, Project Meetings, Regulatory Oversight, Site Visitors; Site Mobilization; RA Activities; Project Documentation; and Site Inspections.

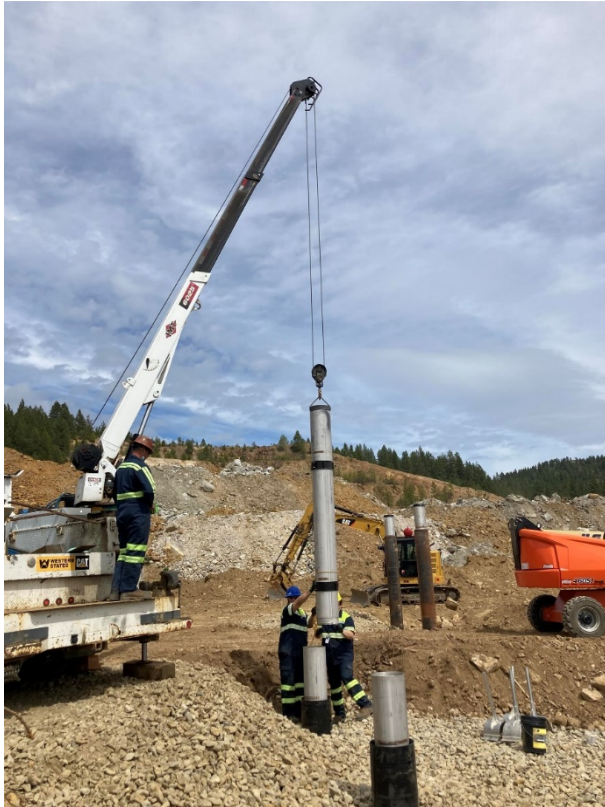
Figure 1 – Installing new section on Pit 4 Vertical Dewatering Riser.

- Newmont extended the Pit 4 Vertical Dewatering Risers.
- Newmont removed wood chips from the Southwest Topsoil Stockpile in accordance with RFI 2021-03 and established radiological control station at the topsoil pile.

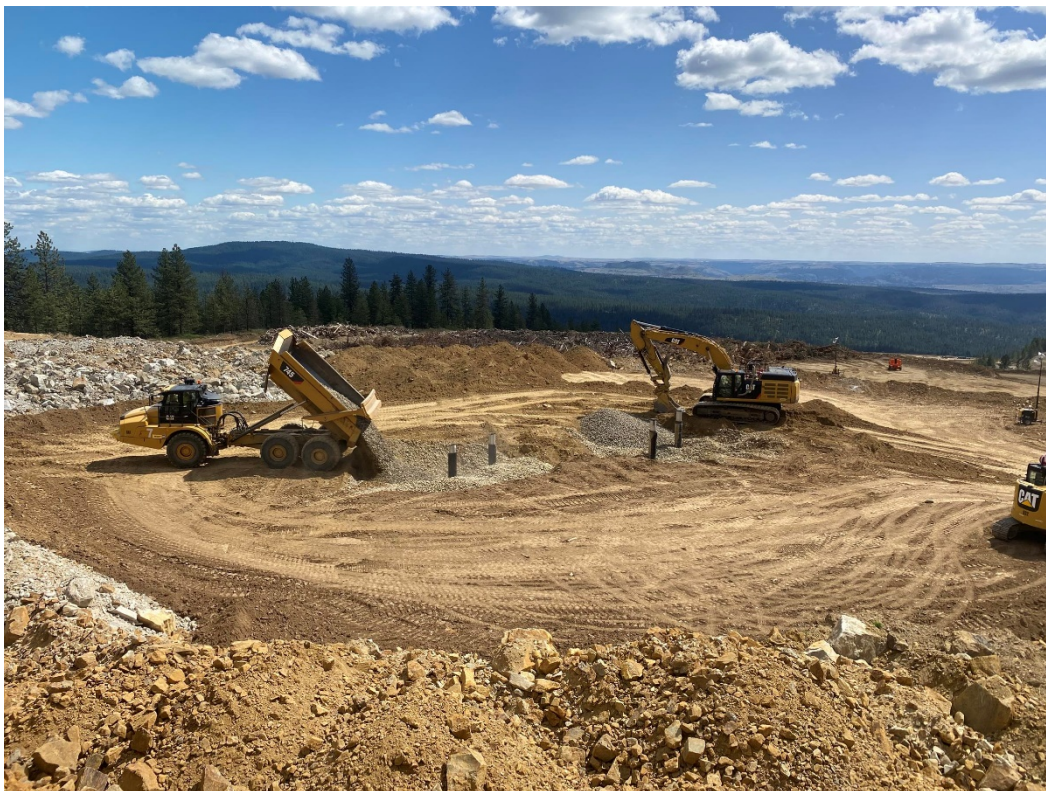
Figure 2 – Backfilling around Pit 4 Vertical Dewatering Risers following installation of new riser sections.

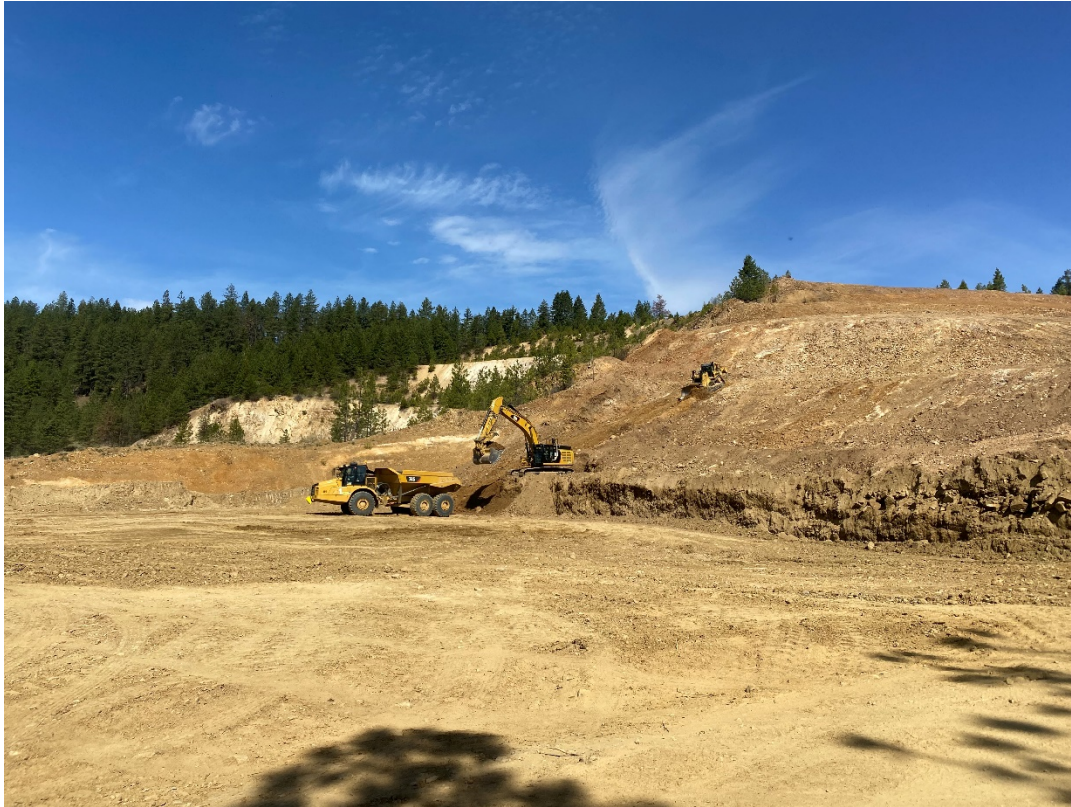
Figure 3 – Excavating and hauling material from Pit 4 Overburden Upper.

- Newmont excavated, hauled and placed low activity/low reactivity material from the west side of the South Waste Rock Pile (SWRP) and the Pit 4 Overburden Pile. Newmont placed these materials along the outside perimeter of the Pit 4 Waste Containment Area (WCA).

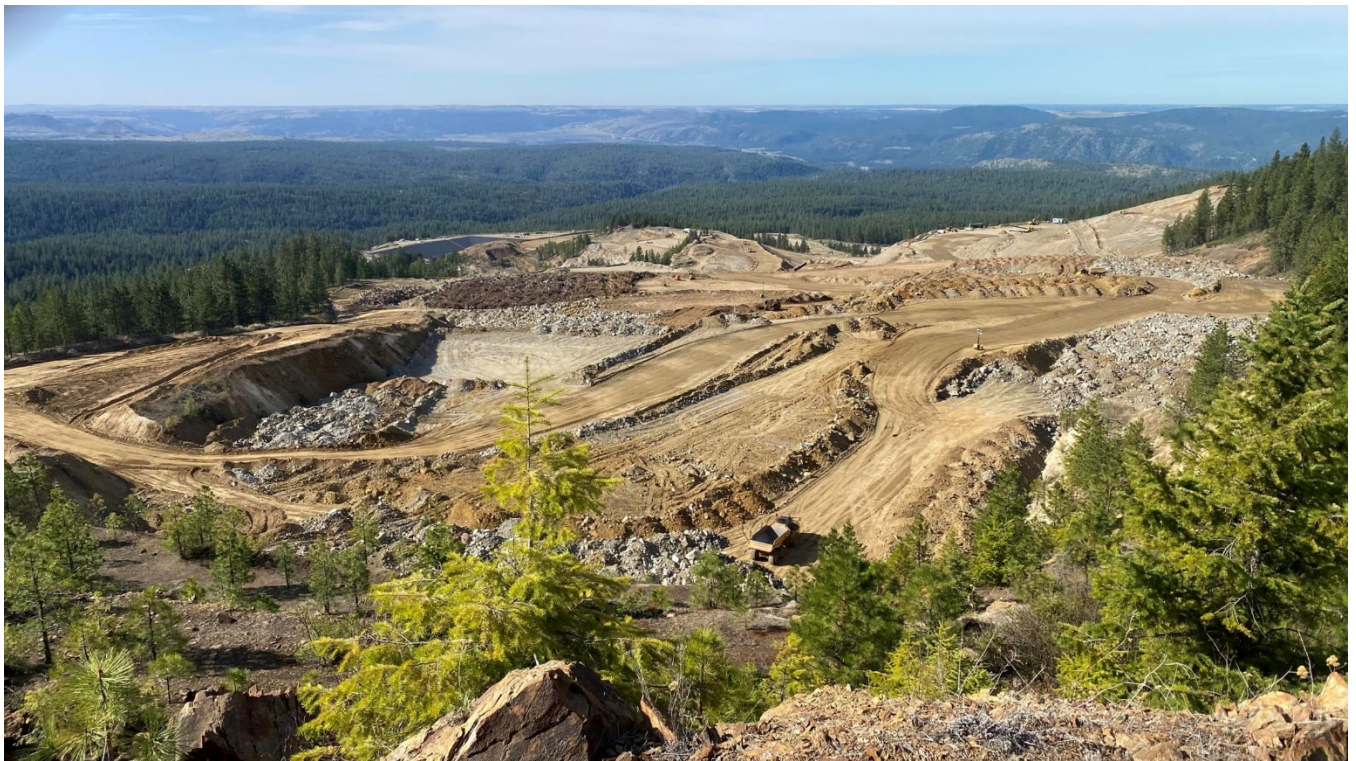
Figure 4 – View of Pit 4 looking South from the Pit 4 Overlook (photo taken 3 May).

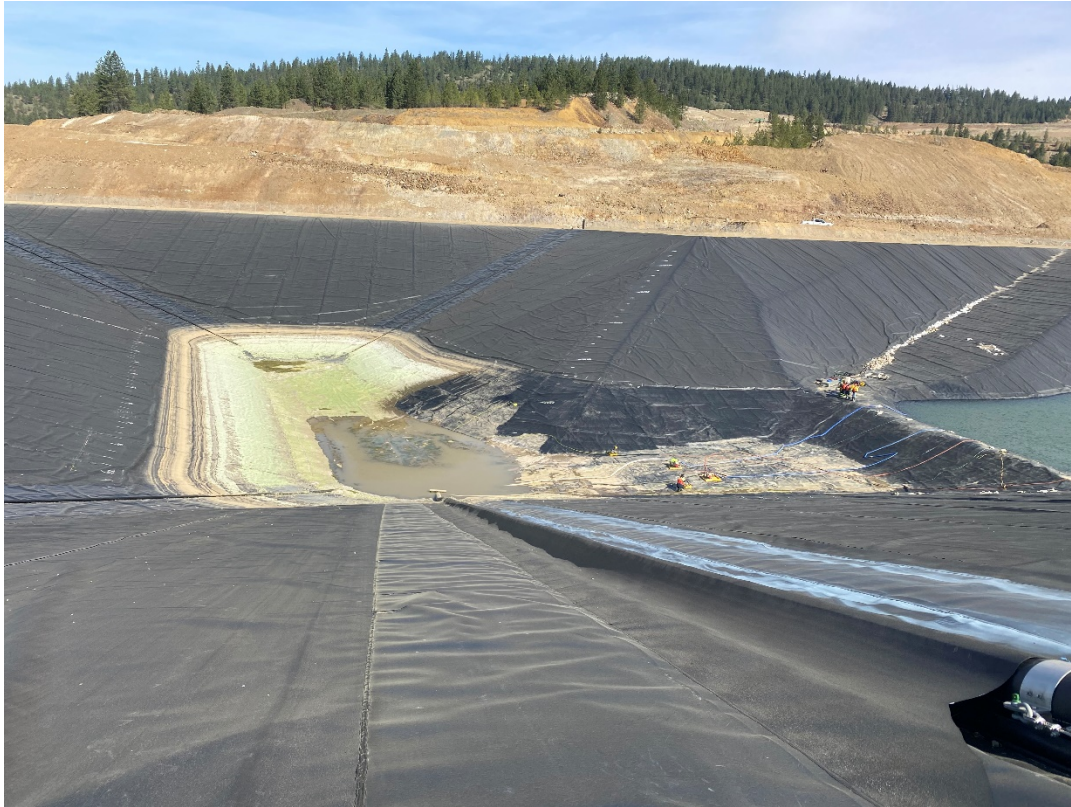
Figure 5 – Cleaning the liner in the West cell of the South Pond (looking East).

- Newmont pumped water from the west cell to the east cell of the South Pond and began removing sediments from the west cell. There are no leaks in the east cell primary liner to a water depth of 14 feet.

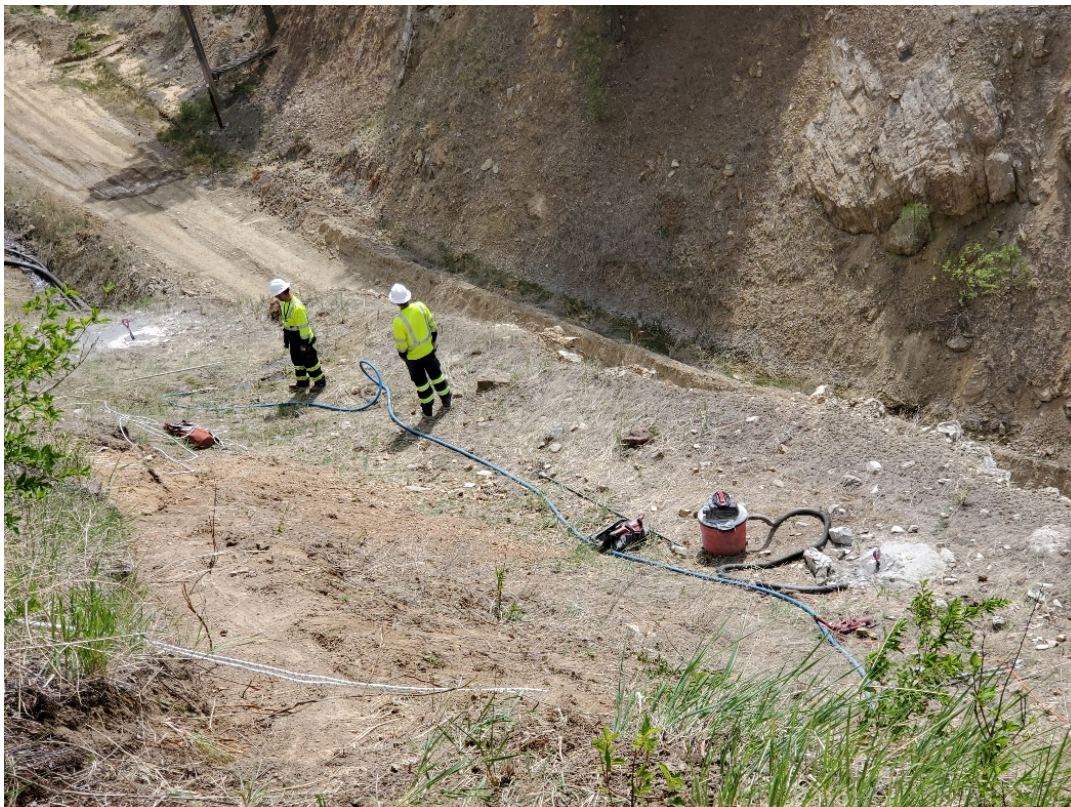
Figure 6 – Hi-Tech Rockfall grouting anchors for the wire mesh drapery system – east side entrance to Pit 3

- Hi-Tech Rockfall continued installing rockfall drapery mesh on the east side of the Pit 3 access road.
- Stantec performed South Pond Embankment Stability inspection on 6 May. The embankment remains stable and movement monitoring points remain within tolerance.

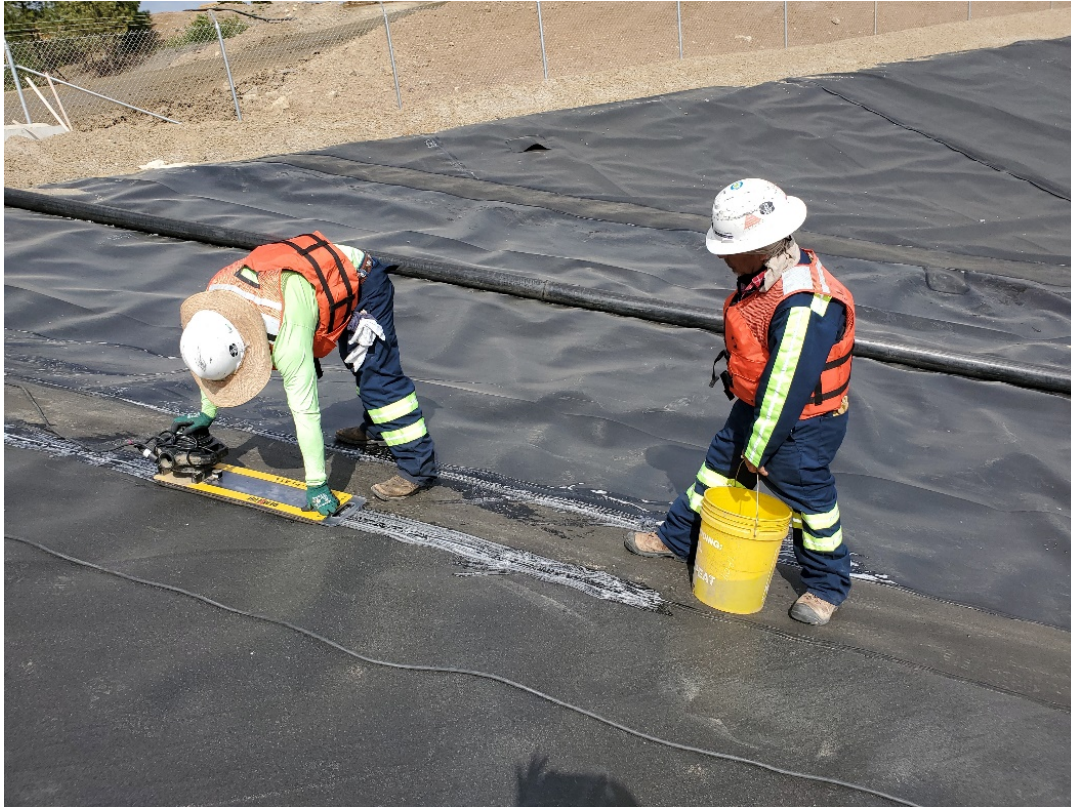
Figure 7 – Northwest Linings testing extrusion welds with a vacuum box

- Northwest Linings completed liner repair activities in the east cell of the South Pond. Representatives from CQC, CQA and Vikek Environmental observed liner repair activities.

- Ongoing South Pond Liner Leak Investigation – East Cell inspections with respect to extrusion-welded patches/caps and visual/vacuum box testing in the East Cell.
- Intermittent Checks on Mine Waste Placement in Pit 4 – Only low activity/low reactivity material from the SWRP and Upper Overburden Pile was placed (5/4 through 5/6/2021).
